Army Lodging Wellness Recommendation

Final Submittal - Presidio of Monterey

February 27, 2004

Presidio of Monterey

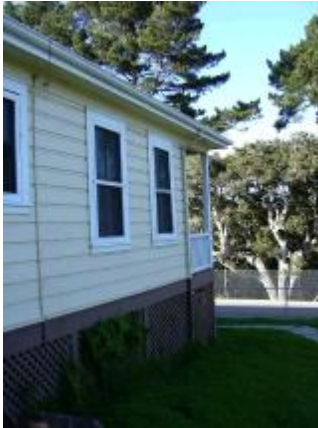
Bldg 354A
Side View
Presidio of Monterey
Monterey, CA

Because the Condition Assessment to Replacement Cost Ratio is greater than 50.00%, repair of Building 354 A is not recommended.

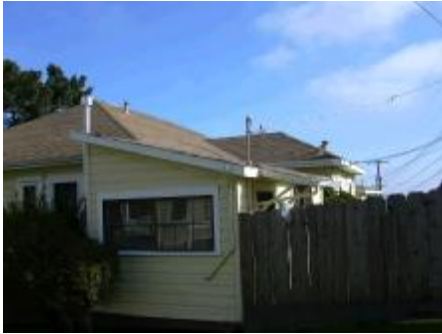
Bldg 354B
Back and Roof
Presidio of Monterey
Monterey, CA

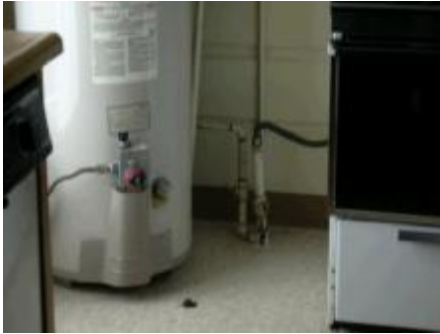
Bldg 354B
Hot Water Heater and Stove in
Kitchen
Monterey, CA

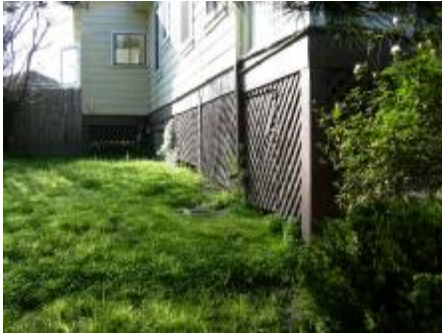
Bldg 356A
Side View
Presidio of Monterey
Monterey, CA

Because the Condition Assessment to Replacement Cost Ratio is greater than 50.00%, repair of Building 356 A is not recommended.

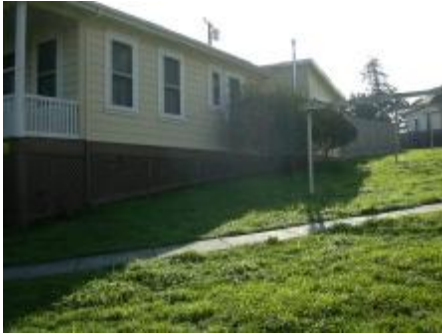
Bldg 356B
Side View
Presidio of Monterey
Monterey, CA

Because the Condition Assessment to Replacement Cost Ratio is greater than 50.00%, repair of Building 356 B is not recommended.

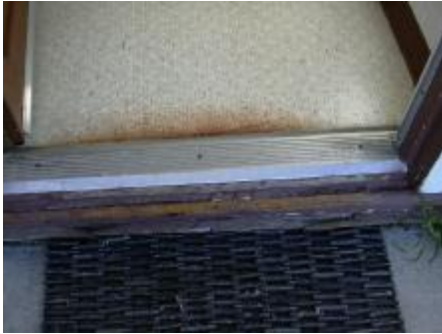
Bldg 356B
Entrance Threshold at Kitchen
Presidio of Monterey
Monterey, CA

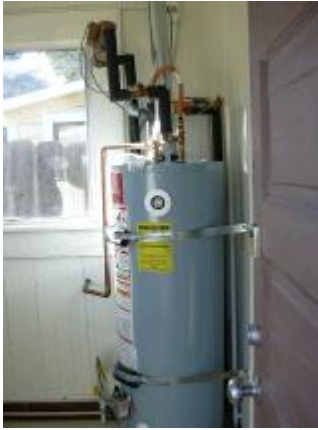
Bldg 358A
Hot Water Heater
Presidio of Monterey
Monterey, CA

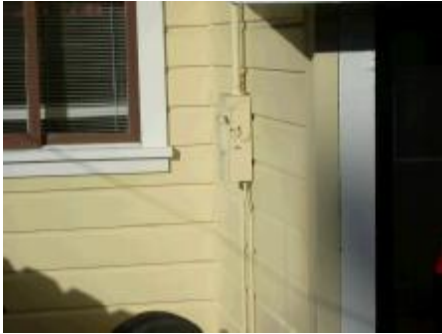
Bldg 358B
Exterior Wall and Window
Presidio of Monterey
Monterey, CA

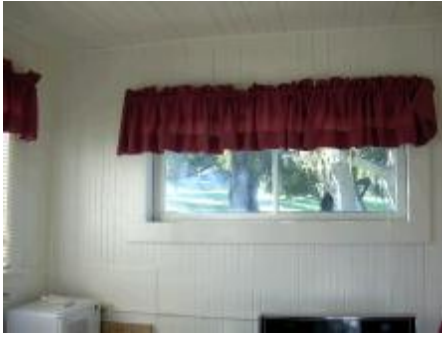
- Analysis: The original wood windows and frames are in poor condition.
- Recommendation: Replace the windows and frames.

***Bldg 358B
Kitchen Window
Presidio of Monterey
Monterey, CA***

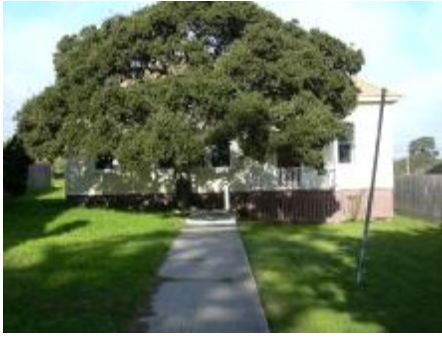
*Bldg 359
Front View
Presidio of Monterey
Monterey, CA*

Because the Condition Assessment to Replacement Cost Ratio is greater than 50.00%, repair of Building 359 is not recommended.

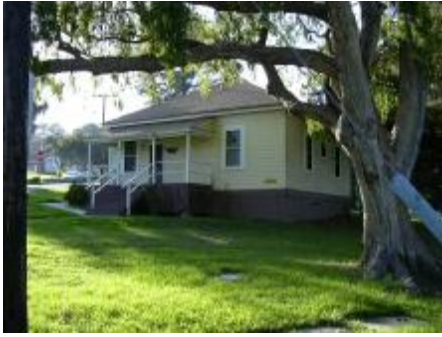
*Bldg 364
DVQ
Front View
Presidio of Monterey
Monterey, CA*

Our recommendation is to remove building 364 from the Lodging inventory, allowing the installation to determine an alternate use for this facility. This facility will be removed from the Presidio of Monterey Wellness Solution and Lodging Master Plan.

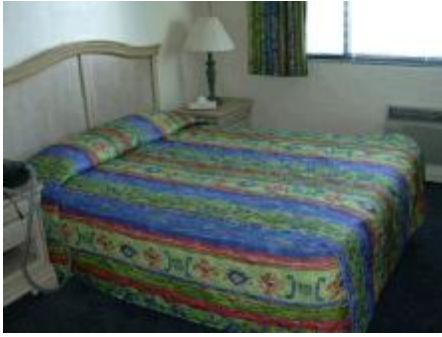
Bldg 366
Main Lodging Facility
Typical Single Bed Room
Presidio of Monterey
Monterey, CA

- Analysis: The single hung, single pane metal windows do not have low E glass. They were installed in 1984 and are in fair condition.

- Recommendation: Replace all windows.
